MERCATO ROOF-LEVEL EXTERIOR WALL: REPAIR & THERMO-SHIELD COATING

August 2011

MERCATO MALL, JUMEIRAH, DUBAI

TOTAL AREA: 4500M²

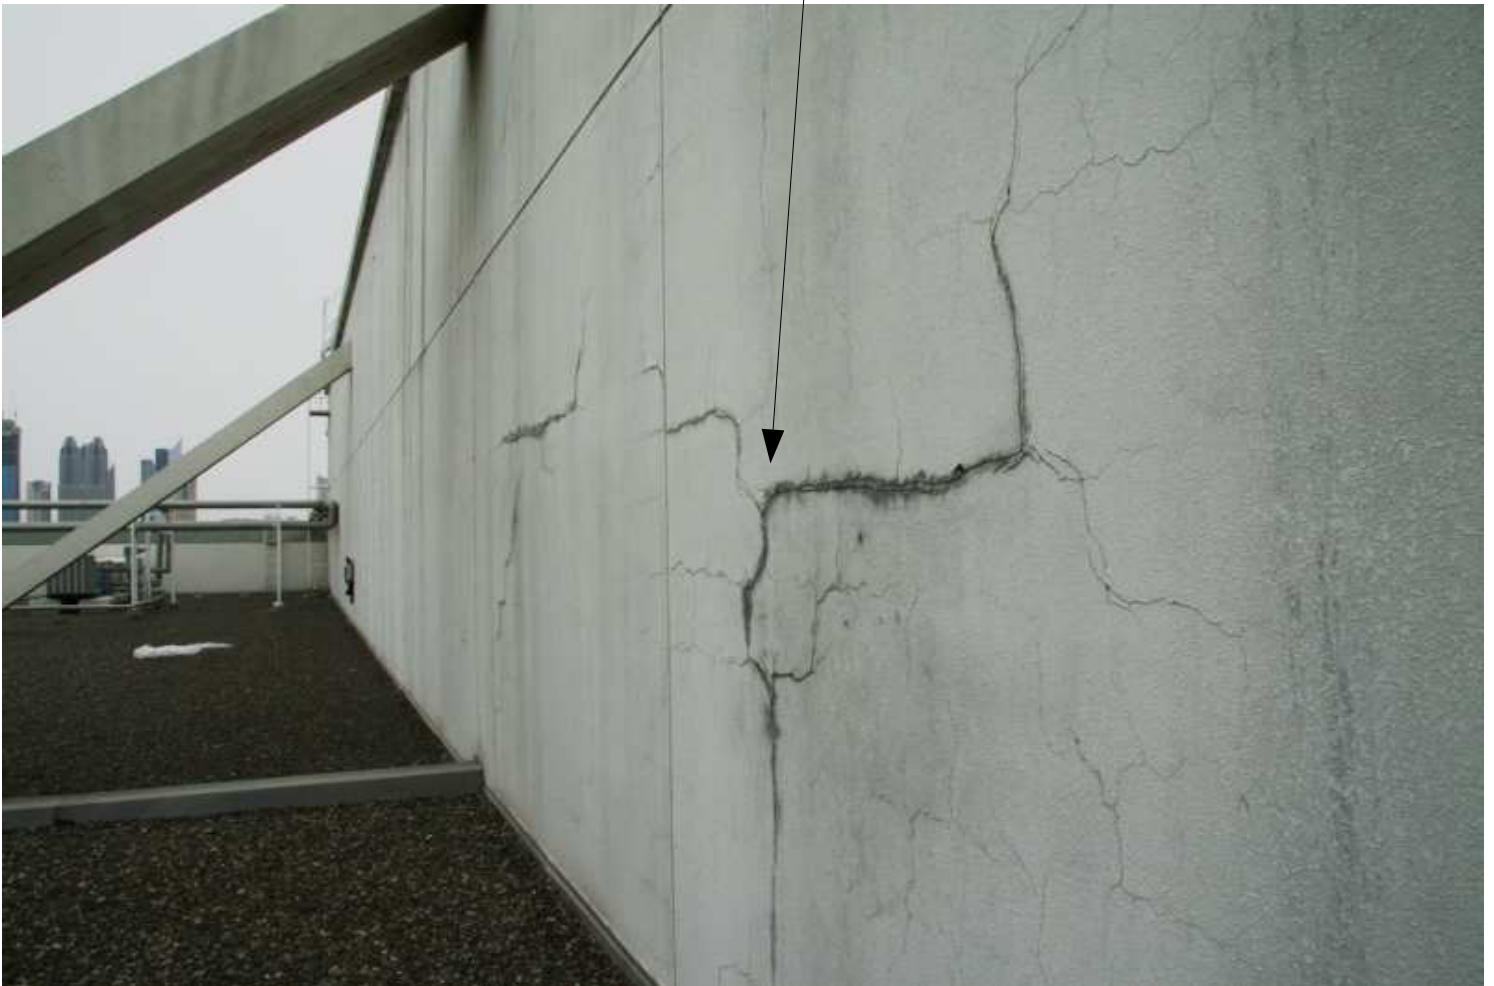
This is the condition of wall before works commenced. Cracks are peppered all over the wall.

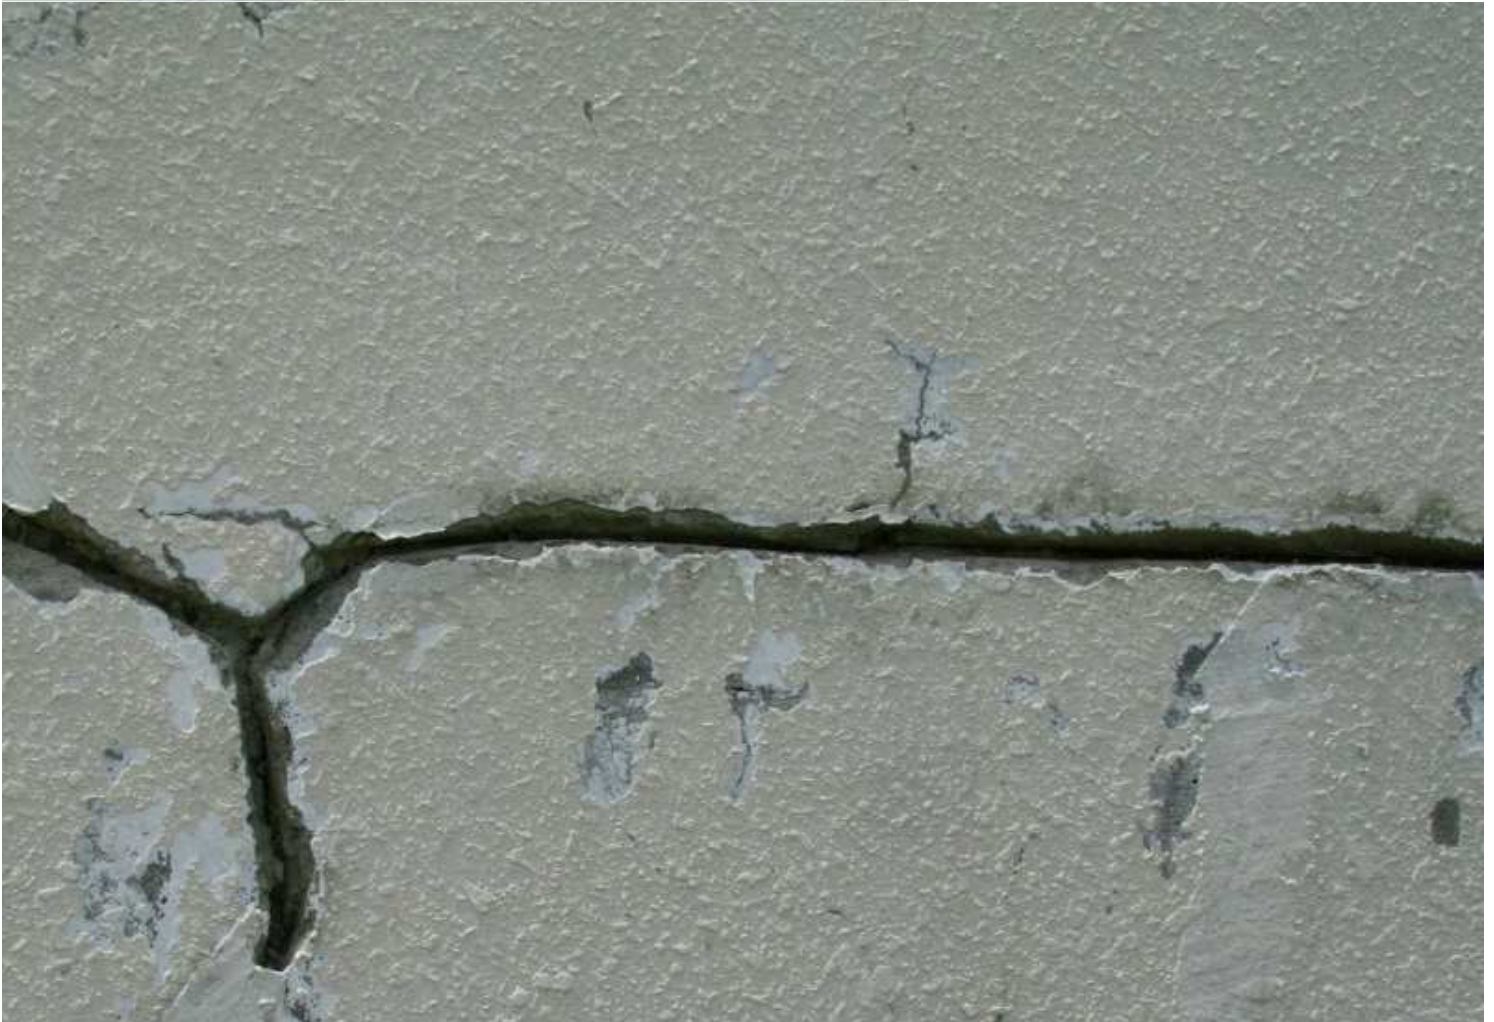
Cracks are exposed. Poor quality concrete mix seems to be the main problem.

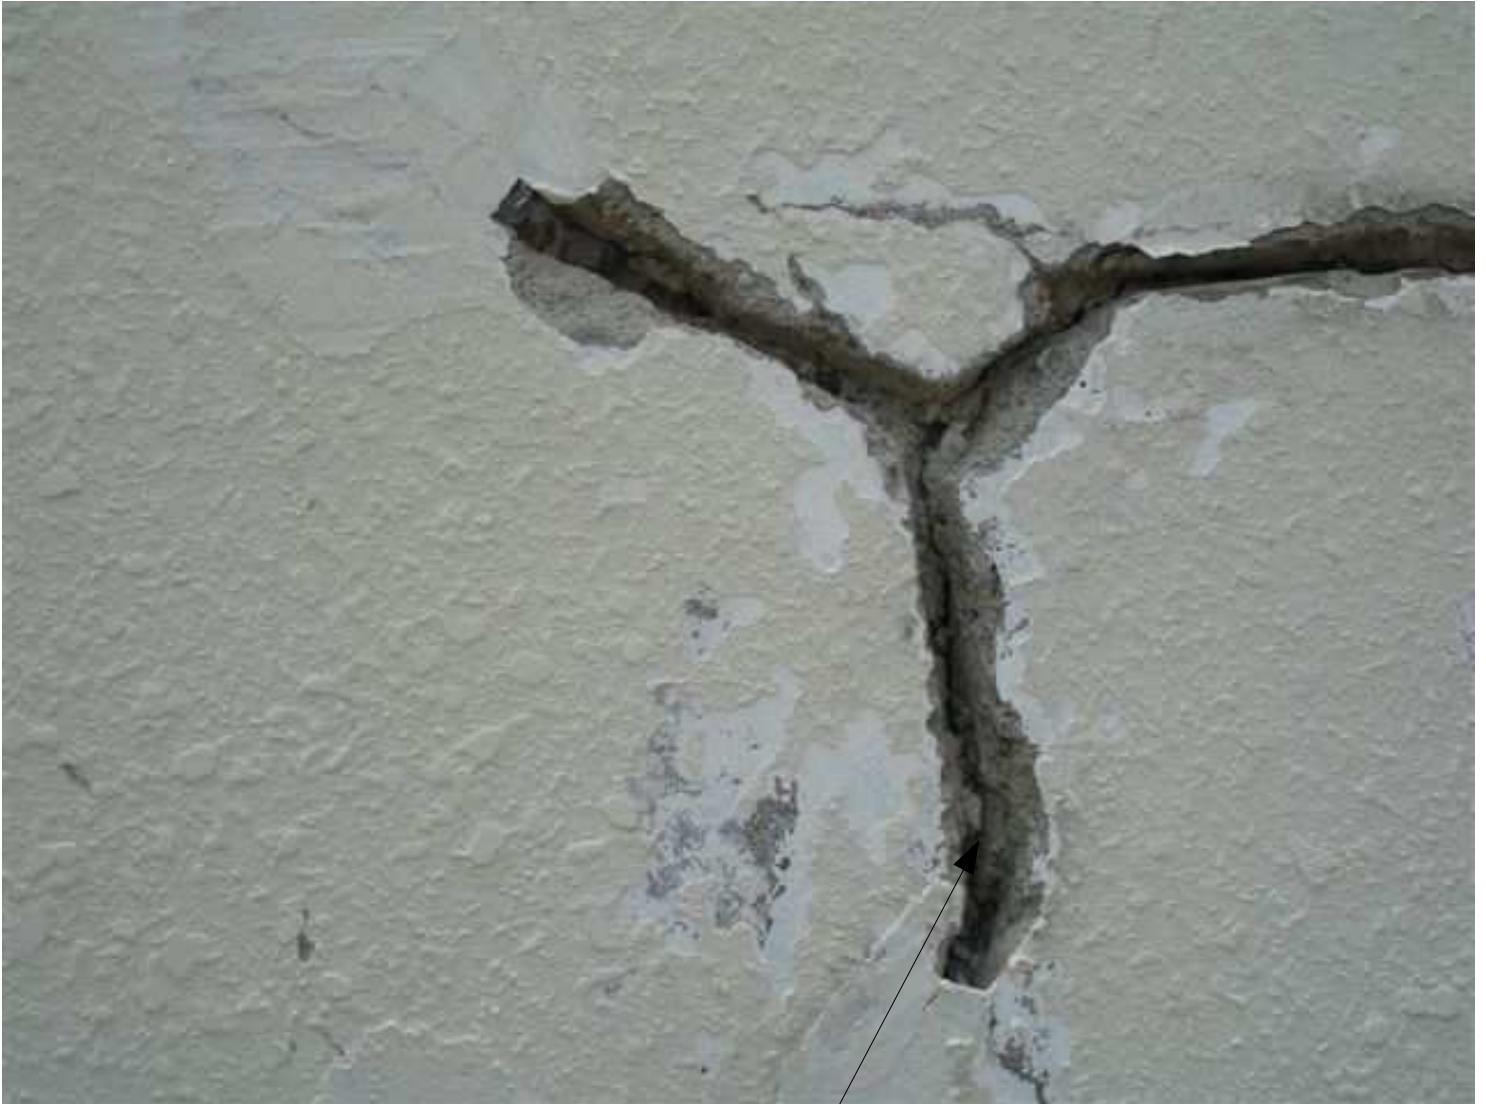
Piece of shell, which was part of the concrete mix!
